THE 2D-BINARY DIVIDER-ITS HISTORY, PERFORMANCE, AND INTERCONNECTION

ORDNANCE CORPS DIAMOND ORDNANCE FUZE LABORATORIES WASHINGTON 25, D. C.

TR-924

10 April 1961

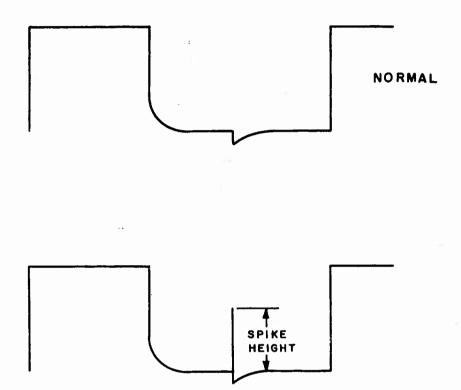
Figure 9. Binary divider output wafers: normal (top) and abnormal because of presence of undesired spike (bottom).

The "spike" in figure 9 was an unwelcome but explainable phenomenon. Any of the following conditions could contribute to a spike

in the binary divider waveform at the point it was observed by momentarily turning "on" what should remain an "off" transistor.

A consideration of the fabrication techniques employed focuses attention on the item "high diode capacitance." As was noted earlier, half-transistors were employed as diodes and because of the larger, and hence more convenient, collector dot, the base-collector junction was jused. Unfortunately this has a relatively high capacitance particularly when compared with a point contact diode, the item usually employed for conventional construction. A suggestion was made to the contractor to begin using the emitter-base diode, and in units delivered later the spike was found to be eliminated or significantly diminished.

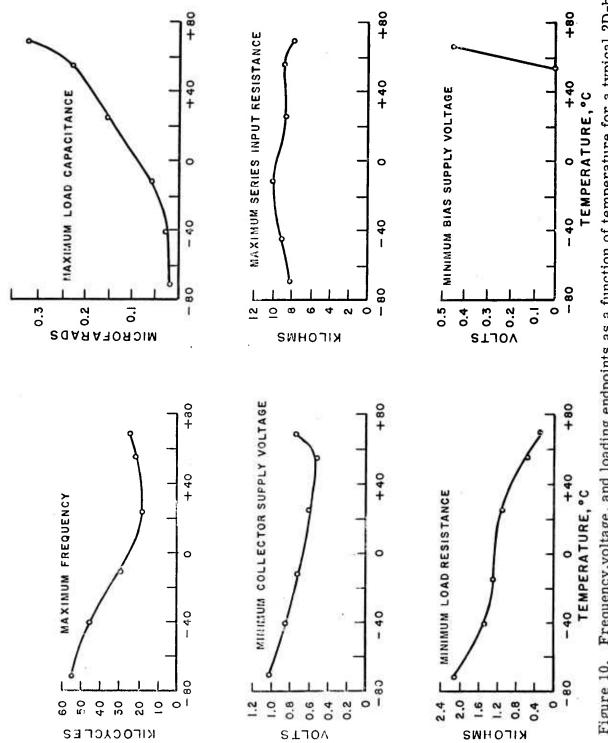
Figure 10. Frequency, voltage, and loading endpoints as a function of temperature for a typical 2D-binary unit.

It should be noted that with standard voltages and loads applied, the 2D-binary dividers currently being manufactured by the Sprague Electric Co. operate from about -70°C to +70°C. Performance becomes marginal at the extremes of this range.

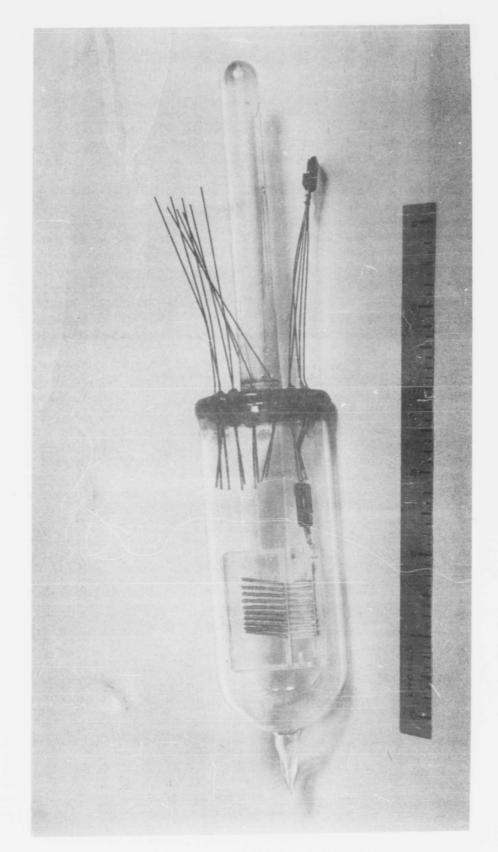
A second glass envelope was constructed containing a countdown assembly composed of ten 2D-binary dividers interconnected by welding (figure 19). This assembly, initially constructed on 2 March 1960, was vacuum sealed and permanently connected to a power supply on 28 June 1960, and allowed to operate continuously at room temperature.

Improper counting was noted from 30 June 1960 on. Instead of the proper countdown of 1024:1, the improper count of 512:1 occurred. The failure was attributed to one defective stage in the assembly which

Figure 19. Hermetically sealed glass envelope employed in testing long-time room temperature operation of a 10-stage countdown assembly.

On 25 November 1960, after 3600 hr of continuous operation, the glass envelope was opened and the countdown assembly examined. Stage 7 of the assembly was found to be mechanically defective; it divided by one instead of two.

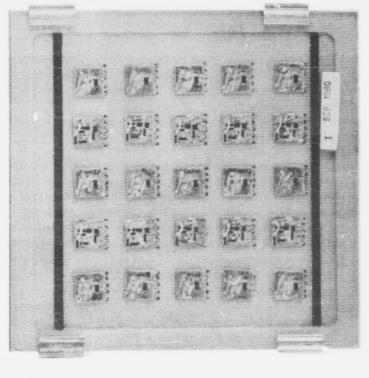
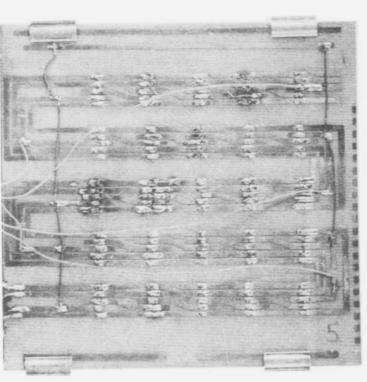
As binary dividers failed, they were removed from the Bingo Board and subjected to failure analysis. New units were soldered into the Bingo Board to replace those that failed. To date, five units have failed in a total of 3000 hr (75,000 unit hours). One failed after 400 hr, two after 500 hr, one after 1300 hr, and one after 1800 hr continuous operation.

Figure 20, "Bingo Board" life test assembly holds 25 1/2-inch square 2D-binary dividers which are kept in continual operation at room temperature.
